U.S. Department of Transportation Federal Highway Administration LTPP Seasonal Monitoring Program Site Monitoring Suspension Status Report Section 251002, Chicopee Massachusetts

## SMP SITE MONITORING SUSPENSION STATUS REPORT MASSACHUSETTS SECTION 251002

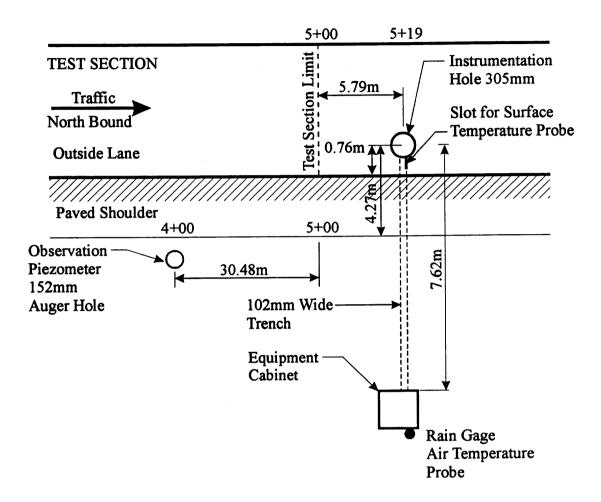
Figure 1. Location for Seasonal Monitoring Instrumentation Installed at GPS 251002

Figure 1 shows the locations of the installed instrumentation at the site. The instrumentation hole is at station 5+19 and the piezometer is at station 4+00. Figure 2 gives the plan view of the portion of test section 251002 that was used for elevation measurements. All offsets are from the PK nails found at the outside pavement edge.

Total Depth of Piezometer: 4.29m
Distance of Piezometer Below Ground Level: 184mm

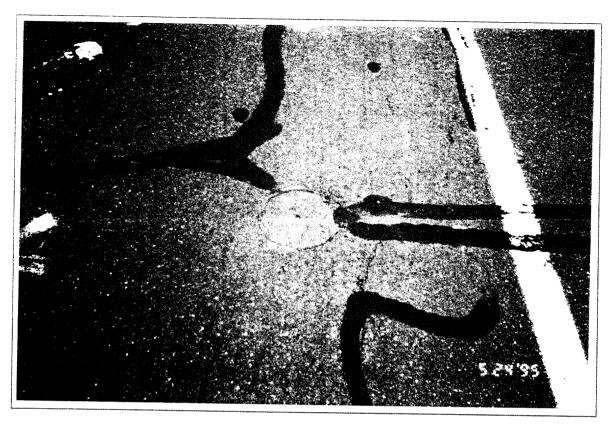
Instrumentation Hole. Seasonal Site 251002 MA, May 1995, Prior to Suspension Preparation Activities

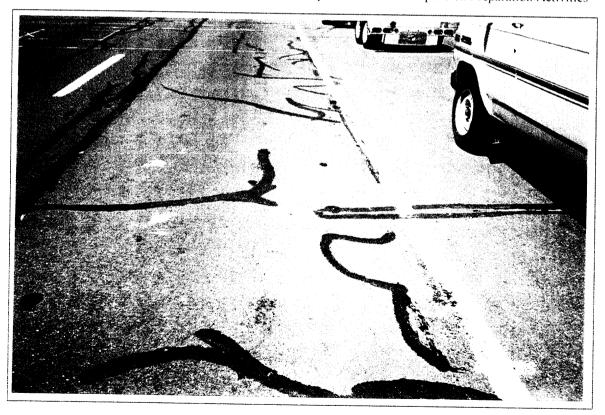
Instrumentation Hole, Seasonal Site 251002 MA, June 1995, During Suspension Preparation Activities
